November 22, 2021

**RE: Overview of Observed Livestock and Damage to Fence and Access Control Area
Proteco Landfill Superfund Site, Peñuelas, Puerto Rico**

ATTACHMENT A
Relevant Site Photographs

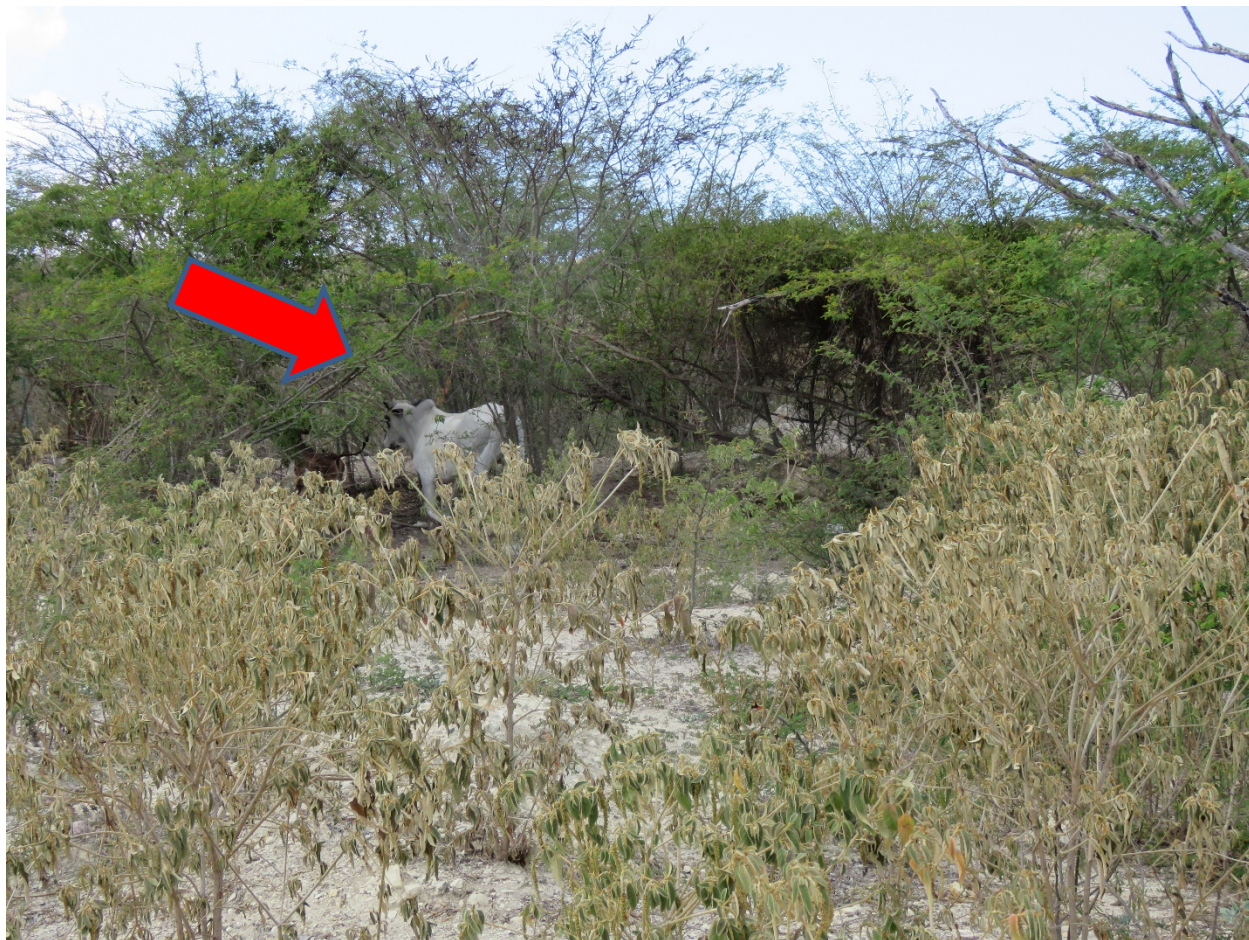
Photo 1. Cattle observed at the Site on June 24, 2021 near disposal unit No. 14.

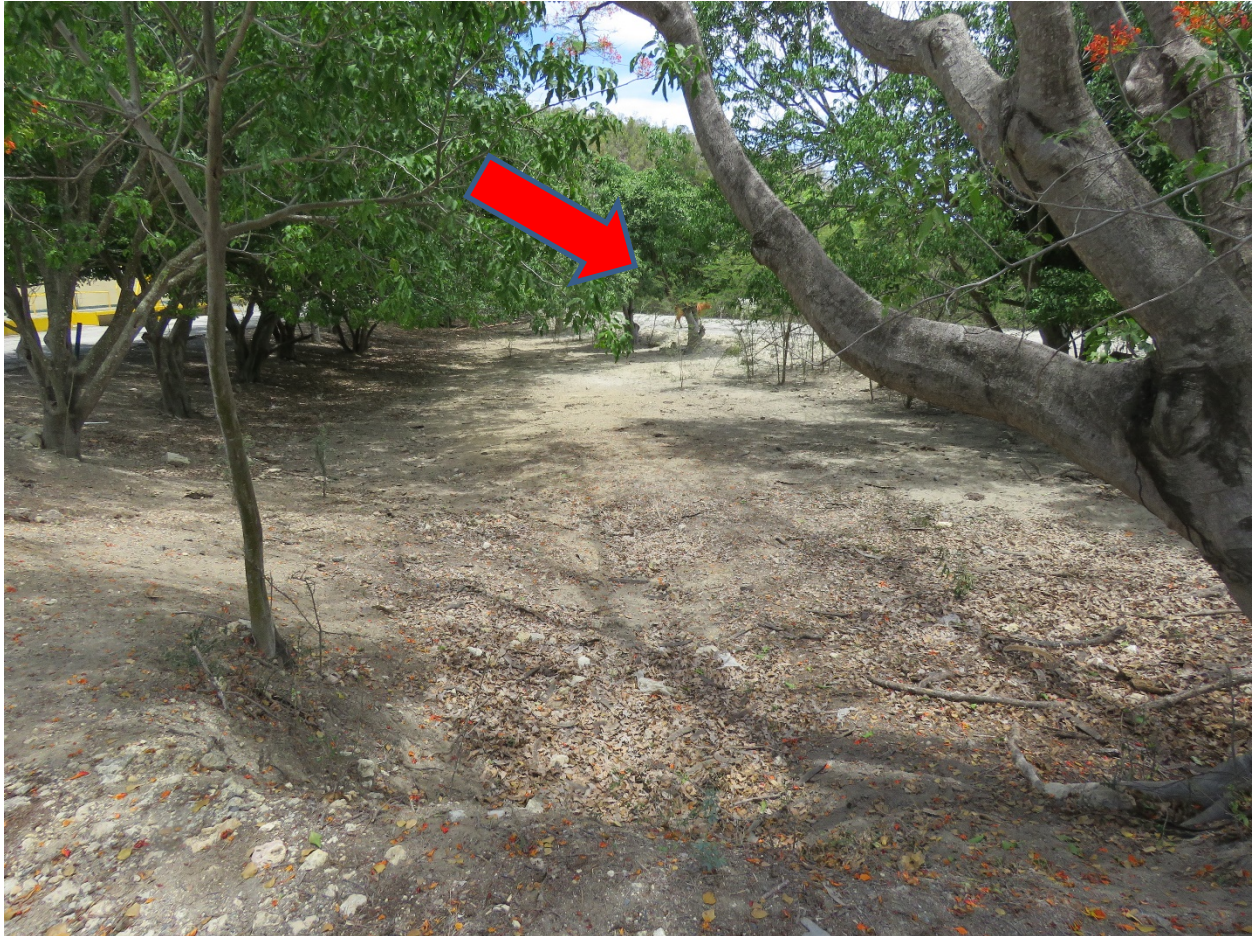
Photo 2. Cattle observed (in the far background) along the access road to the south of the Site on June 24, 2021.

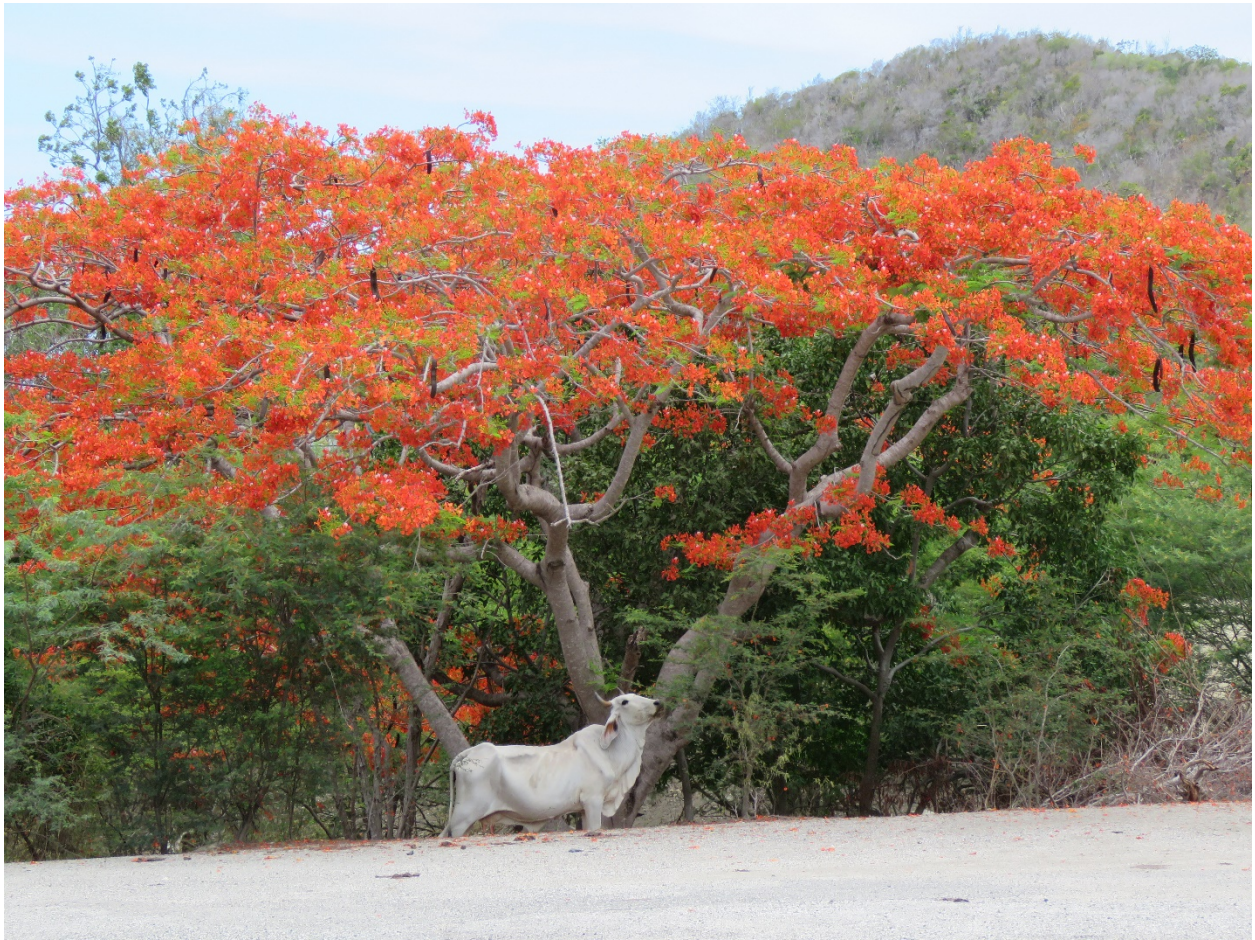
Photo 3. Cattle observed across the main access road, outside and near the south area of the Site on June 24, 2021.

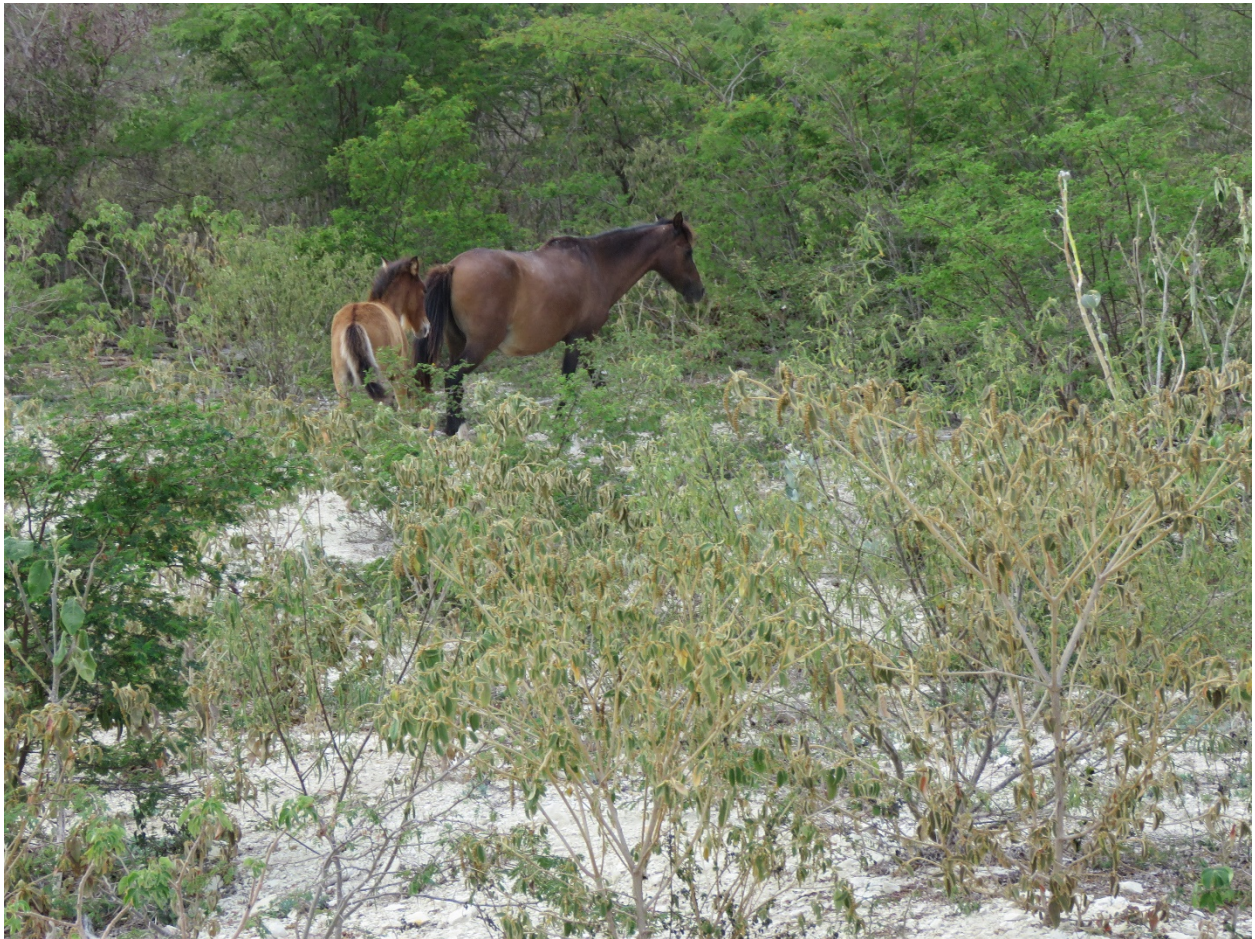
Photo 4. Horse and foal observed at the Site near waste disposal unit No. 6 on June 24, 2021.

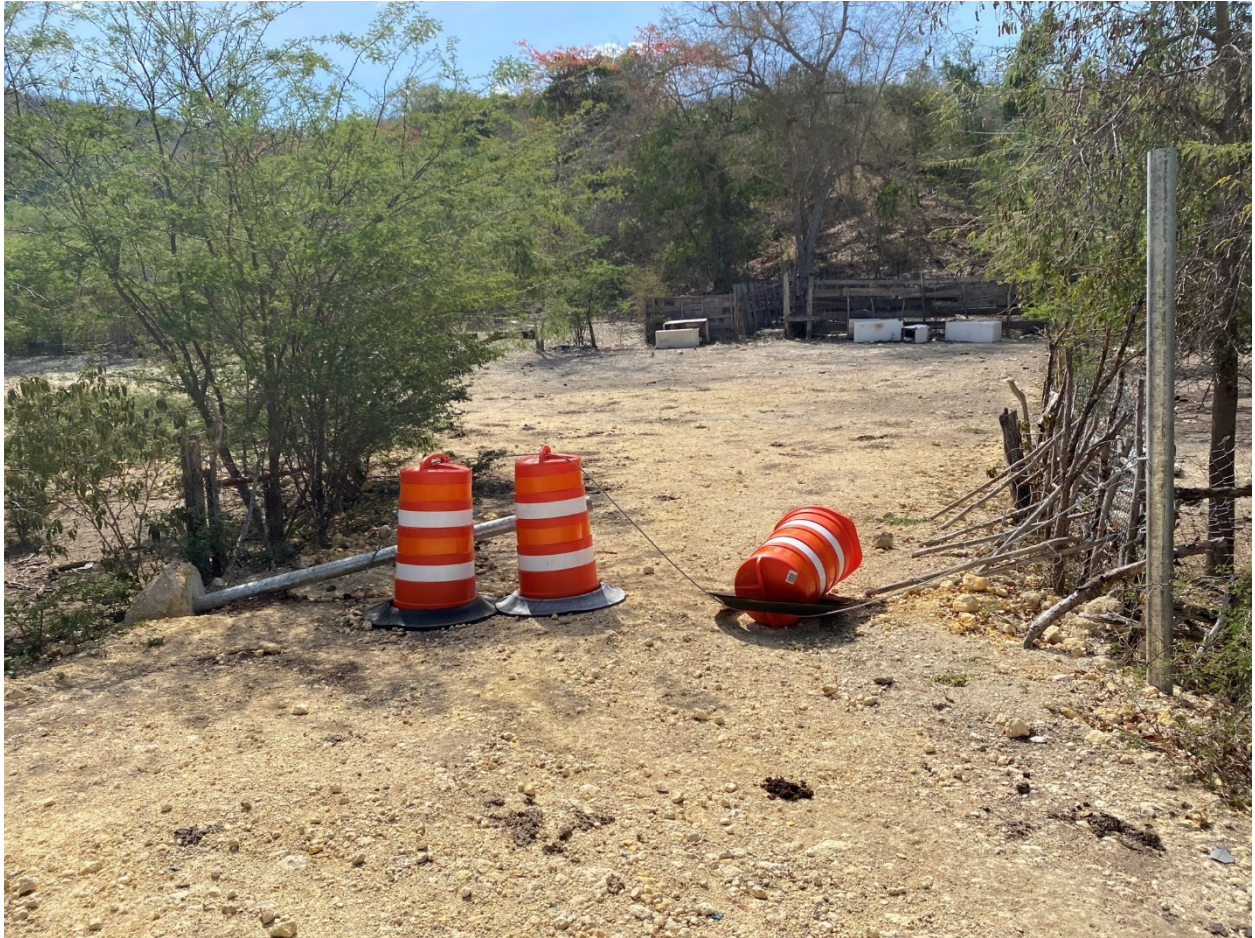
Photo 5. Damaged post of the access barrier on west-central area of Site documented on June 24, 2021. Makeshift water troughs and cattle pens are observed in the background.

On June 23-24, 2021, Geosyntec and *de maximis* conducted a Site visit, during which we observed approximately more than 30 individual animals (cows, calves, bulls, horses and foals) within the Site premises, as well as on several areas of the main access dirt road leading to the Site (Photos 1 to 4). Additionally, Geosyntec and *de maximis* noted damage to the access control barrier post on the west entrance to the Site (Photo No. 5). Additionally, several locations along the west perimeter of the barbed-wire fence appeared to have been cut and which allows the livestock to enter the Site. The damaged post was subsequently repaired by Rightway Environmental on August 18-19, 2021.

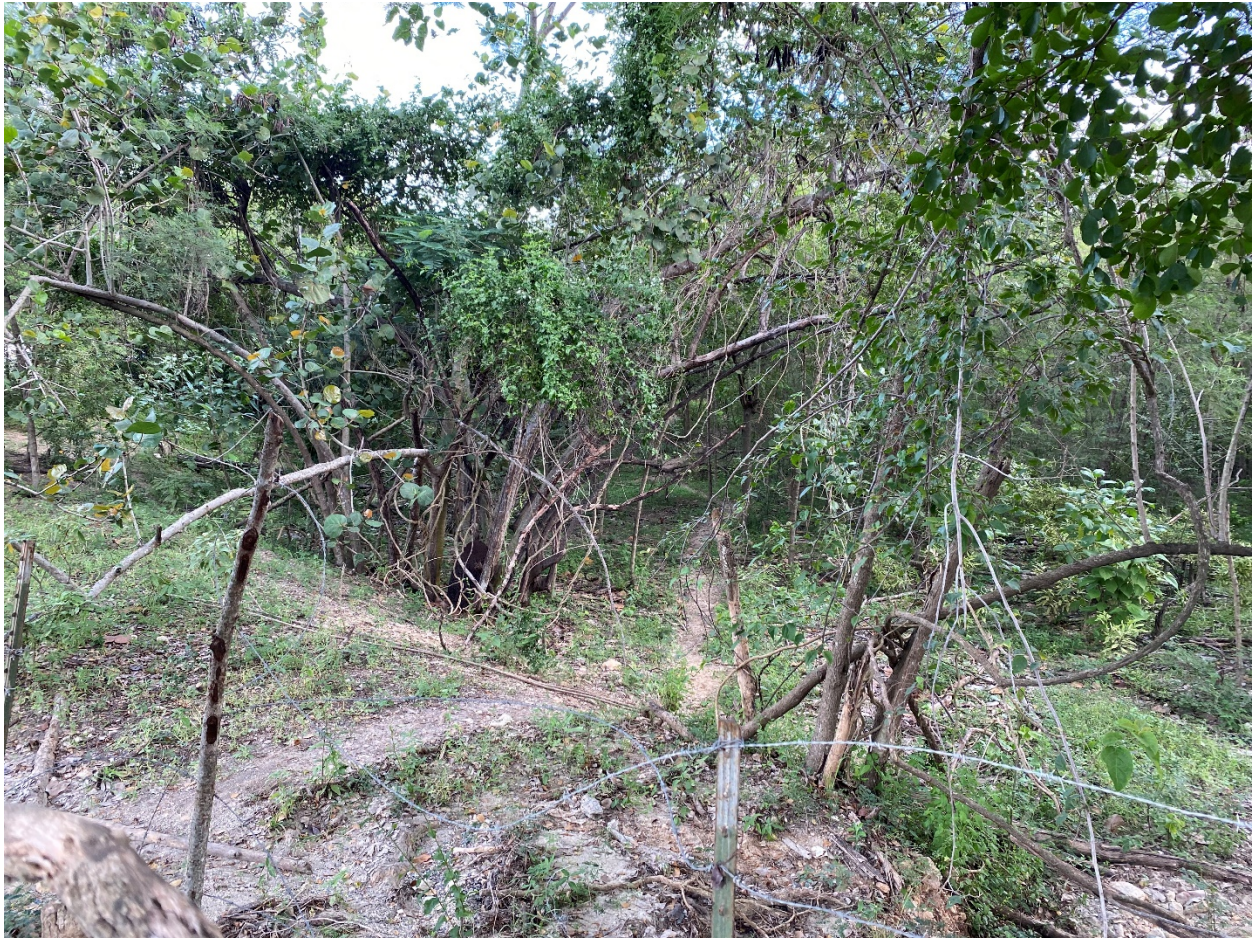
On November 3-4, 2021, Geosyntec returned to the Site to conduct oversight of a biological survey for endangered species at the Site. The survey was conducted by Diatom Environmental, LLC (Diatom). Both Geosyntec and Diatom personnel observed several sections of the barbed-wire fence which were broken or cut near the southern perimeter of the Site (Photo No. 6). We also observed numerous cattle trails and encountered several groups of the animals within the north, central and southern areas. More than two dozen cattle and horses were observed by Diatom and Geosyntec. The livestock could not be clearly photographed due to obstructions of dense vegetation. The survey team maintained proper distance from the herds as a safety precaution. The survey team also observed that the corral structures and water troughs previously used to maintain cattle at the Site are still present near the west-central entrance the Site.

Photo 6. Section of broken (cut) barbed-wire fence and cattle trail near the south boundary of the Site observed on November 3, 2021. View is northeastward towards the Site.
